PROJECT REPRESENTATIVE'S DAILY REPORT

Pg. 1
Report No. 083
Date: 2014-12-16
Day: Tuesday

Project: Renovation and Addition to Tewksbury Town Hall

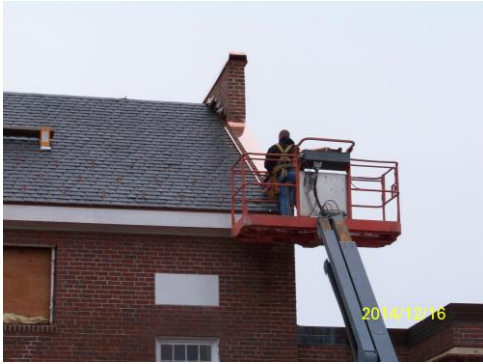
A photograph showing a roofer on a red lift platform installing cap flashing on the north end of a brick building. The date stamp '2014/12/16' is visible in the bottom right corner of the photo.	<p>Photo showing roofer installing cap flashing on north end of main building.</p>

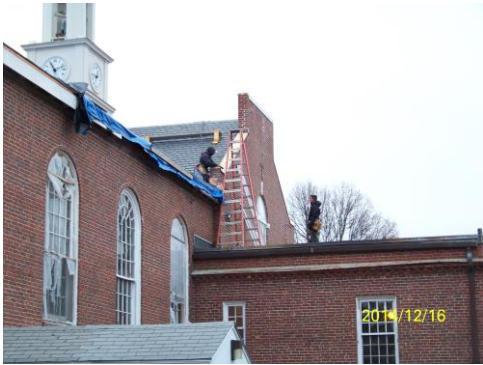
A photograph showing roofers installing cap flashings on the south end of a brick building. The date stamp '2014/12/16' is visible in the bottom right corner of the photo.	<p>Photo showing roofers installing cap flashings on south end of main building.</p>

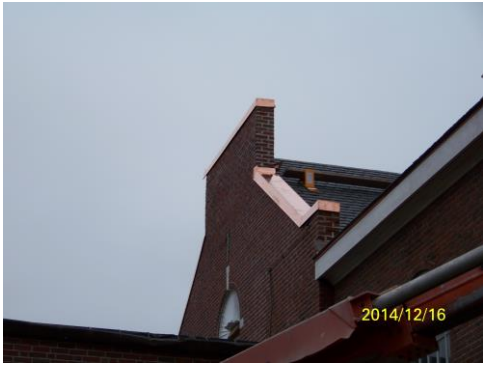
A photograph showing completed cap flashings on the west side and top of a north parapet. The date stamp '2014/12/16' is visible in the bottom right corner of the photo.	<p>Photo showing completed cap flashings on west side of north parapet and top of north parapet.</p>

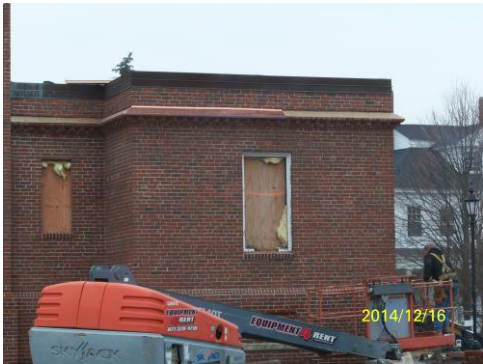
A photograph showing water table flashing in the process of being installed on the north wing of a brick building. A red and blue lift is visible in the foreground. The date stamp '2014/12/16' is visible in the bottom right corner of the photo.	<p>Photo showing water table flashing in the process of being installed on the north wing.</p>

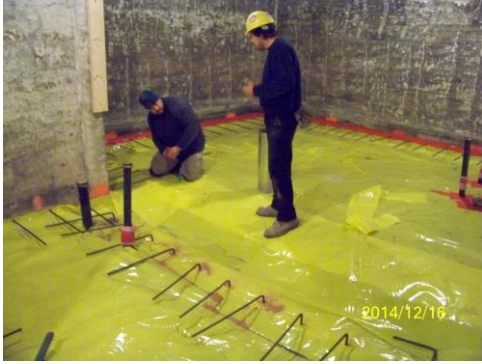
Photo showing workmen in the process of installing the vapor barrier in the south end of the basement.

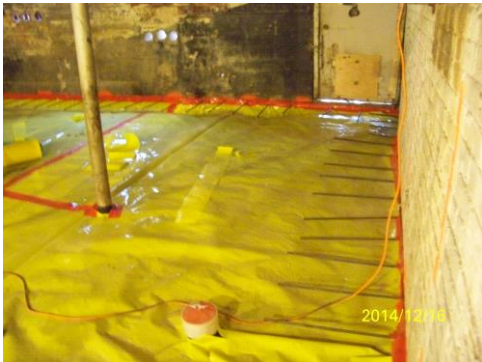
Photo showing the vapor barrier in place in the south end of the basement. The reinforcement will be placed tomorrow and the concrete placement is scheduled for Thursday, 12/18.

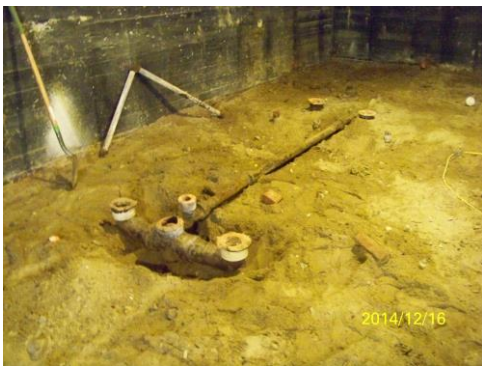
Photo showing subgrade plumbing to be removed from the north wing of the basement.

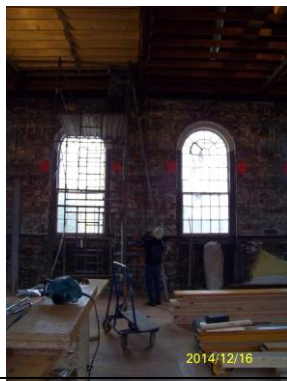
Photo showing workman hoisting channel for 2nd floor framing.

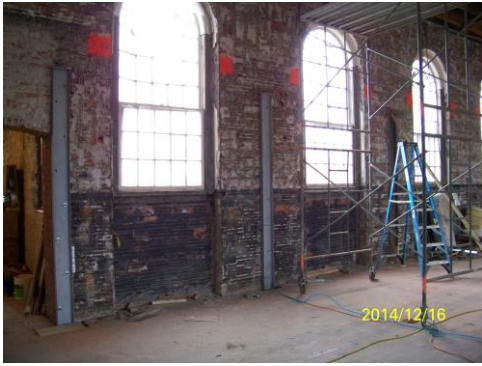
Photo showing channels in place along the south wall of the meeting hall.

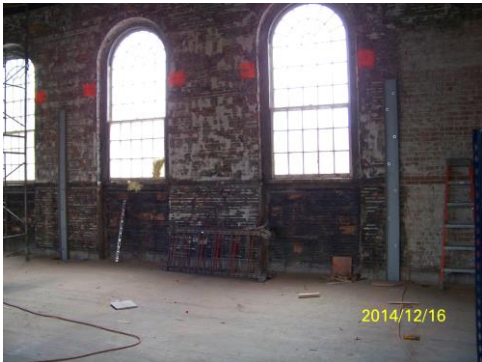
Photo showing channels in place along the north wall of the meeting hall.

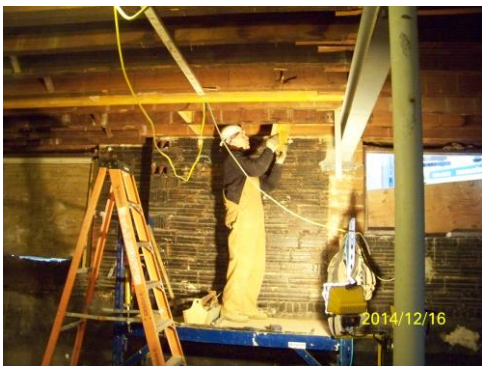
Photo showing carpenter installing tie-backs. This is along the west wall of the basement.

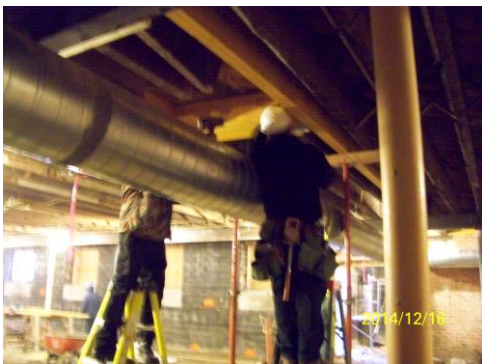
Photo showing carpenters finishing up the installation of the LVL beams at the east end of the basement.

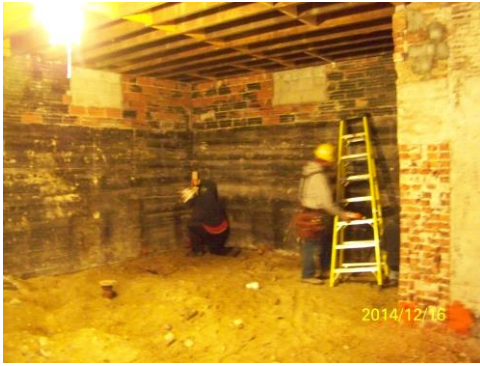
Photo showing carpenters laying out grade lines for the framing of the new work to be installed in the north wing of the basement.

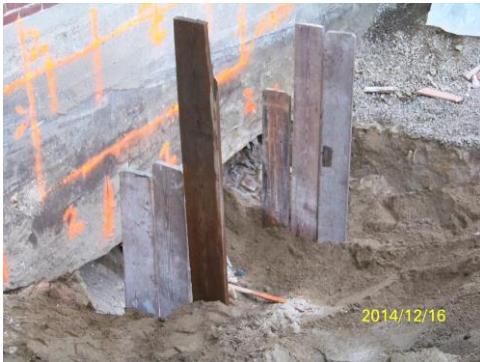
- 4) Site Work: installing plank sheathing at excavation location in an attempt to mitigate undermining; excavating and continuing drain pipe installation in parking lot

Photo showing planks used as sheathing to mitigate undermining of the interior of the building.

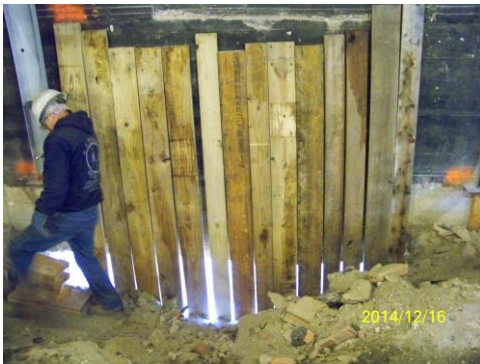
Photo showing planks used as sheathing to mitigate undermining from the interior of the building.

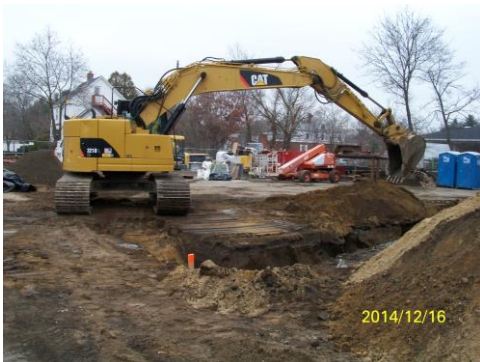
Photo showing excavation for the drain pipe in the parking lot.

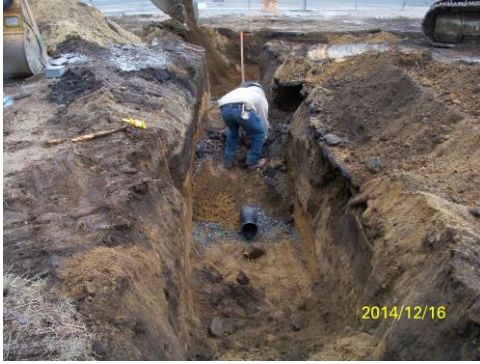
Photo showing drain pipe in place.

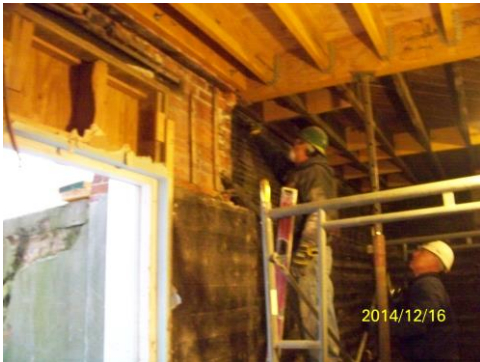
Photo showing masons working on rebuilding a section of masonry inside the basement along the northwest wall.

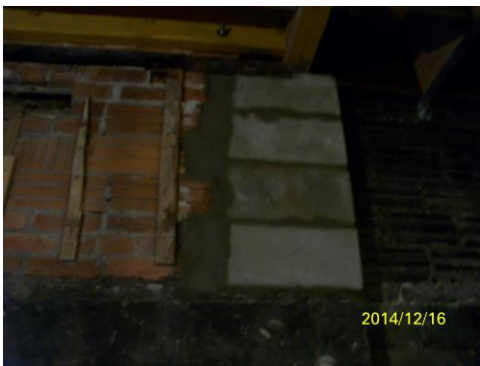
Photo showing rebuilt area at the northwest wall.

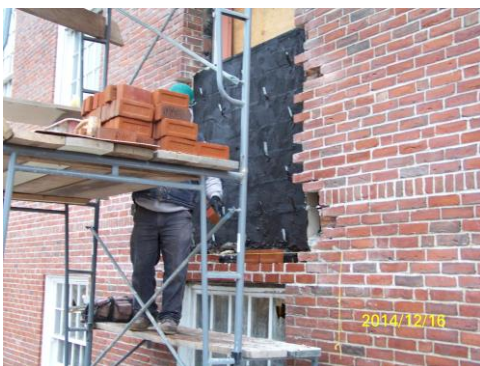
Photo showing mason laying brick at the new window opening after applying waterproofing material and installing the new lintel.
